3D characterization of rolling contact fatigue crack networks

Published in:
Wear

Publication date:
2016

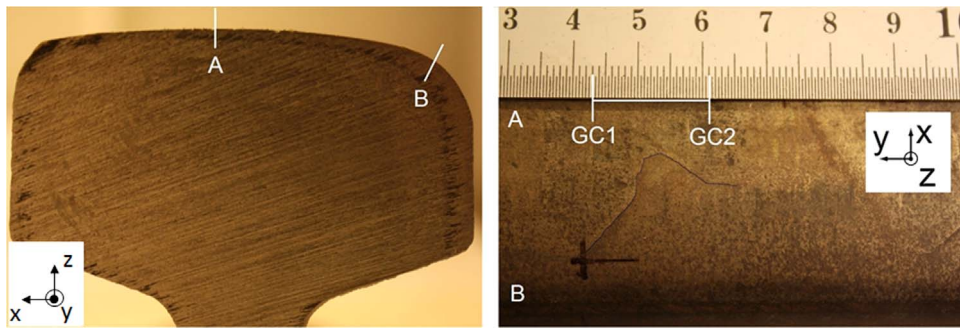
Fig. 1. Squat with gold cross marks (GC1, GC2) and scale (the V-shaped surface-breaking crack has been traced to be more visible).

Squats are surface-initiated defects, characterized by their V-shaped surface-breaking crack and two-lobe darkened surface [6], and are classified within three classes: A (light), B (moderate), and C (severe), according to [8,9]. Fig. 1 shows a Category B squat. The initiation of squats is thought to originate due to local plastic deformation of the surface from rolling contact fatigue (RCF) loading, including dynamic wheel-rail contact forces [1]. When local thermal damage on the rail surface is believed to affect the initiation mechanism, the defect is rather referred to as a stud [1,7]. In this work we have not determined the cause of initiation due to limited background information, and have chosen to use the name ‘squat’ for the defects studied.

Investigations were carried out on squats taken from different rail sections taken from the field. A first squat was radiographed and thereafter cut in slices which were subjected to metallographic preparation. Before X-ray exposures, reference position indicators (GC1 and GC2 in Fig. 1) were placed on the surface of the rail in order to locate the squat network in 2 dimensions (x and y), while a geometrical analysis was done using the radiographs in order to obtain the third dimension (z) required for the 3D reconstruction of the crack network. The line through the gold crosses corresponds to $x=0$ mm, while the center point between GC1 and GC2 defines $y=0$ mm. A second squat, taken from a different rail section, was investigated by X-ray tomography. For this, a 10 mm deep section, 10 mm along the rolling direction and 30 mm in the transverse direction, was extracted from the center of the rail running surface (see Fig. 3). A third squat was broken open and the topography of the bulk-side was measured (Fig. 4).

In order to evaluate the ability of the X-ray imaging, subsequent image analysis and 3D reconstruction, to correctly visualize the real 3D geometry of the crack, metallographic cross-sectioning was done at different y-positions on the rail sample shown in Fig. 1. The surfaces were prepared by grinding with SiC paper, diamond polishing, and etching with nital 2%. Examination of the prepared surfaces was done using a Zeiss Stereo Discovery V20 stereomicroscope and a Leica light optical microscope (LOM). The series of sections obtained were analyzed using image processing in MATLAB to position the depth of the crack relative to

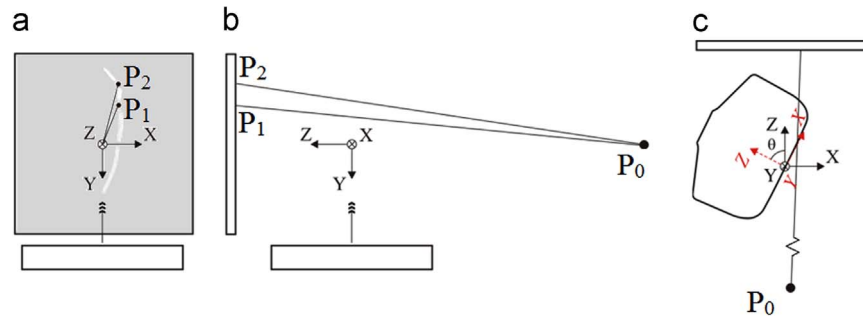
Fig. 2. Radiographic set-up and system for geometrical reconstruction: (a) front view (as seen from the X-ray tube) and (b) view from left side, showing rotation table and symbolic detector, and (c) top view, showing rail sample and symbolic detector. The rail standing on the rotation table is excluded in a and b, and the rotation table itself is excluded in c for improved visibility.

In this study, the use of radiography combined with 3D reconstruction, metallography, X-ray tomography, and topography measurement were evaluated as methods to describe the geometry of RCF crack networks. A first squat taken from the field was examined by radiography and metallography, in order to observe the network of cracks, and to investigate the ability of radiography and image analysis to reconstruct the 3D shape. This was verified by comparison with measurements of crack extension on metallographic cross-sections. Metallographic investigation of the material adjacent to the crack faces, was also performed. X-ray tomography was performed on a part of another squat for high-resolution 3D visualization of the crack network. A third squat was opened and the topography of the bulk-side crack face was examined by stereomicroscopy and stylus profilometry. The radiography and geometrical reconstruction methods have previously been presented at the 35th Risø symposium on Materials Science and are documented in the proceedings [19] (Fig. 2).

The parts of the crack which provide the highest contrast in each image (as projected on the detector) are mapped manually on the images. An illustration is shown in Fig. 2a, where two such points called P_1 and P_2 are selected. The path between the points, $\overline{P_1P_2}$ is assumed to be a straight line and identifies a part of the crack where the radiation is parallel to the crack plane. The larger the curvature as projected on each image, the closer the points are recorded. The plane, S_n , is obtained from the vector $\overline{P_1P_2}$ and the point P_0 positioned in the X-ray source (Fig. 2b). When the object has been rotated by an angle $\Delta\theta$, new points P_1 and P_2 are selected. A new vector $\overline{P_1P_2}$ is obtained, and the next plane, S_{n+1} , is calculated. The lines of intersection between the individual planes and the vectors $\overline{P_0P_1}$ and $\overline{P_0P_2}$ give the endpoints of each plane. The midpoint between intersection line endpoints is equal to the tangent to the crack plane, which gives the z coordinate of the crack (Fig. 2c). The result was plotted in MATLAB [20].

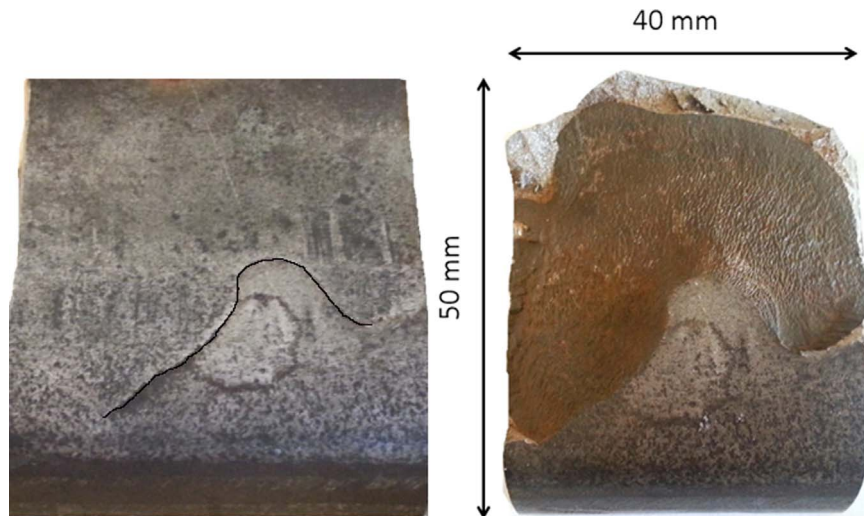
Fig. 4. Category B squat rail surface before (left, slightly tilted) and after (right, showing bulk-side crack face) being opened for topography measurements.

depth description was acquired. An overall geometry was obtained using 1 mm step size over the 40 by 40 mm² area of the squat (Fig. 4), while detail maps were done on smaller regions with step size 50 μ m to allow for the ridges to be measured.

An investigation of the topography of the squat on a macro scale was done using stereomicroscopy and stylus profilometry. The fatigue crack path can clearly be followed from the origin to the outside edges, as shown in Fig. 4. Stereomicroscopy images of the same crack are shown in Figs. 11 and 12 shows the mapping from the topography method. A closer examination of the surface (Fig. 11b) shows ridges, very pronounced in certain areas as described by the 3D surface profile in Fig. 13, and occasional beach marks. The mappings obtained, clearly show the texture and roughness of the squat surface, also visible by the X-ray tomography, which are not captured by radiography through the entire rail head nor can be clearly imaged using metallographic sectioning since only one perpendicular plane is imaged.

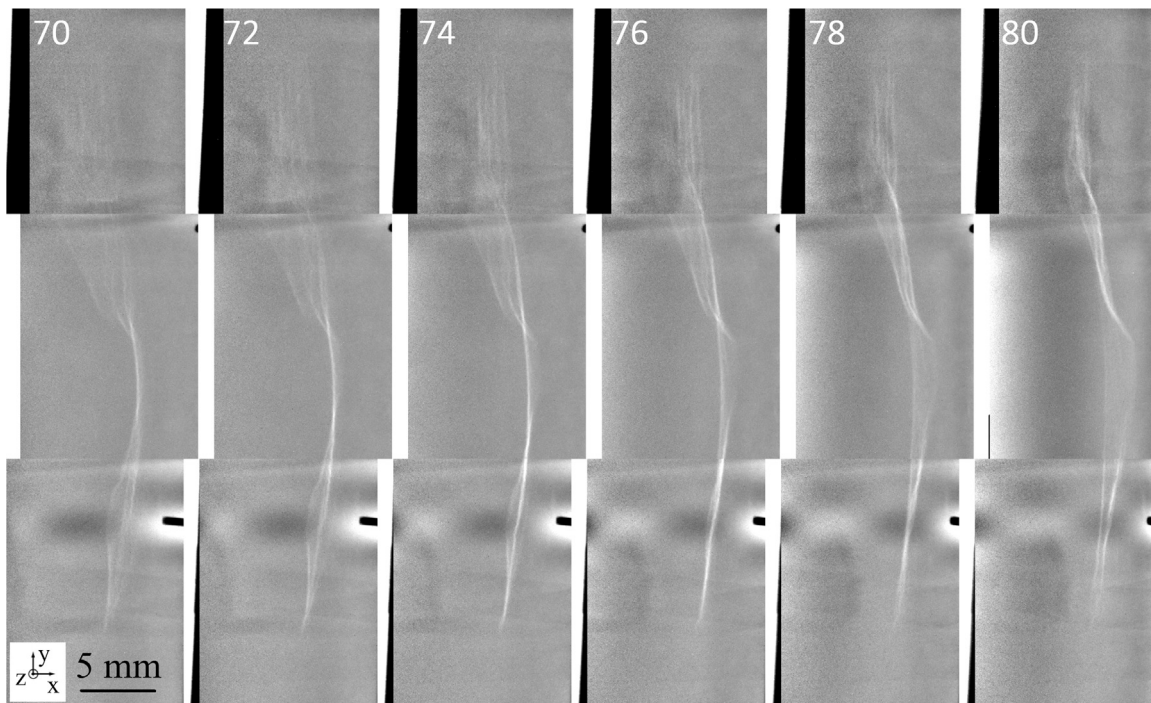
Fig. 5. Superposed X-ray image sequences of squat, ranging from 70° to 80°.

The radiographic images obtained after corrections and enhancement allow observation of a given area of the squat crack network, without tampering. Fig. 5 shows a compiled sequence of images from the squat between the angles of +70 and +80°, with 2° intervals, according to the previously described radiography set-up (Fig. 2). It can clearly be observed how the intensity increases as the crack normal becomes perpendicular to the incoming X-ray beams. Artefacts are caused by joining images to cover the entire length of the crack, as well as from the necessary mathematical treatment of images. These artefacts currently hinder a fully automated interpretation of images.

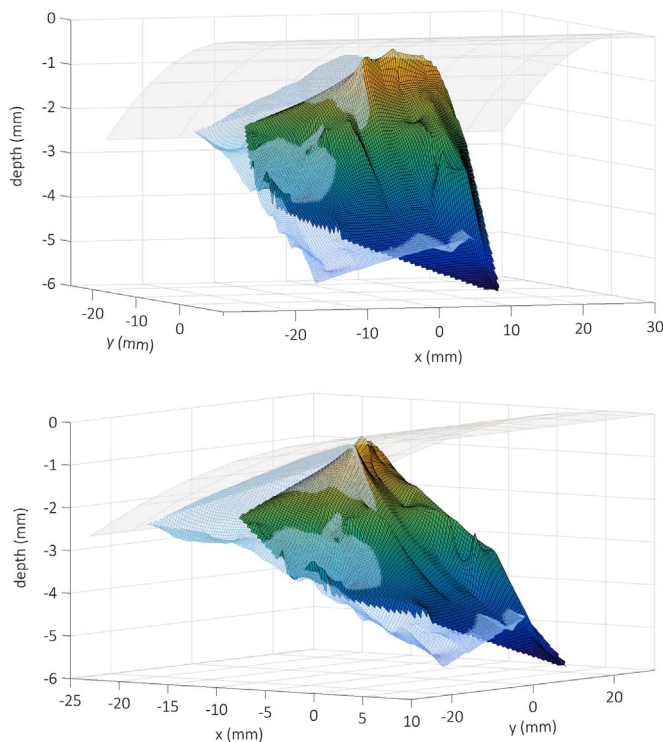
Fig. 6. 3D plots with surfaces obtained from both 3D reconstruction (colored) and metallography (mesh). The crack network is showed relative to the rail surface (gray). Note that the scaling in z-direction is exaggerated to better show the shape of the crack. (For interpretation of the references to color in this figure legend, the reader is referred to the web version of this article.)

The result of the 3D geometrical reconstruction is shown in Fig. 6, demonstrating a section of the squat network which is similar to that reported in literature [21].

in Fig. 7c. Closer to the tip, the opening of the crack may be too narrow for detection with the given resolution. Side branches can be hidden due to limited angles; they never become parallel to the radiation. The surface obtained through the reconstruction is compared to that from metallography in Fig. 6. Although the depth can be estimated, the direction of the crack close to the crack tip provides important information on the severity of the squat. This means the detection in-field is always one step behind, which is a severe drawback when predicting whether the squat will cause further damage, such as transverse fracture or surface shelling. Perhaps this can be solved by combining it with complementary NDT techniques.

also be observed that the reconstructed crack geometry does not extend to y-positions beyond the surface-breaking part of the crack, represented in Fig. 6. That is, the peripheral parts of the squat which lie entirely below the surface cannot be detected unless it extends to the surface, due to the tight closure which exists.

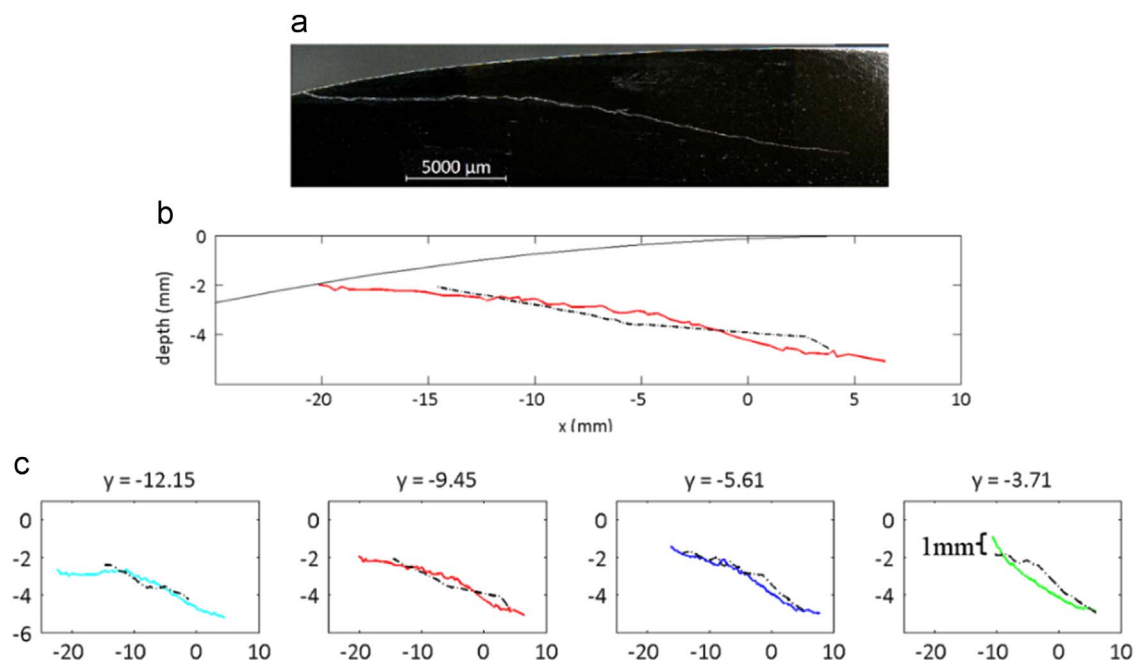
Fig. 7. (a) Transverse cross-section of the squat, (b) from reconstruction (dash-dotted black line) and metallography (solid red line). (c) Reconstruction (dotted lines) and metallography (solid lines) comparisons. It should be noted that the depth is exaggerated in (b) and (c). (For interpretation of the references to color in this figure legend, the reader is referred to the web version of this article.)

Metallographic cross-sectioning was done to determine the accuracy of the geometric reconstruction and also for evaluation of this traditional method as a means to characterise a squat crack. Fig. 7a shows a transverse cross-section of the rail. The comparison between the metallography and the reconstruction shows the reliability of the method for accurate reconstruction of the crack network to a certain extent (Fig. 6), as well as for evaluation of squat severity. It can be seen in the bottom right-hand corner of Fig. 7b that the crack penetrates deeper and further into the rail than seen in the 3D reconstruction, due to the tight closure of the crack tip, making it indistinguishable using radiography through the full rail head. It should be noted that the depth axis is exaggerated in the figures in order to better show the texture of the

crack obtained through metallographic sectioning. Similarly, the surface-breaking section of the crack was not always present in the 3D reconstruction, since planes were plotted assuming piecewise parallelism, there is a limit to the degree of curvature that can be interpreted. The method, however, was found to give a reliable description of the geometry of the crack on medium depths; that is, each curve measured from the metallographic cross-section follows well the interpolated curve from the reconstructed surface, as shown in Fig. 7c.

For the geometrical reconstruction technique, some characteristics of radiography, such as sensitivity to alignment between the X-ray beam and crack, are used in order to obtain a visualization of the complete squat network. It is this characteristic which helps to sort out the normal of the crack plane in each image. Combining information about shape, crack plane orientation, relative movement with respect to the reference position indicators, as well as comparisons between different angles of exposure; a 3D reconstruction is possible. It was found that this radiographic technique provides information on the crack network geometry, however lacks some accuracy in positioning the crack tip, which can be seen

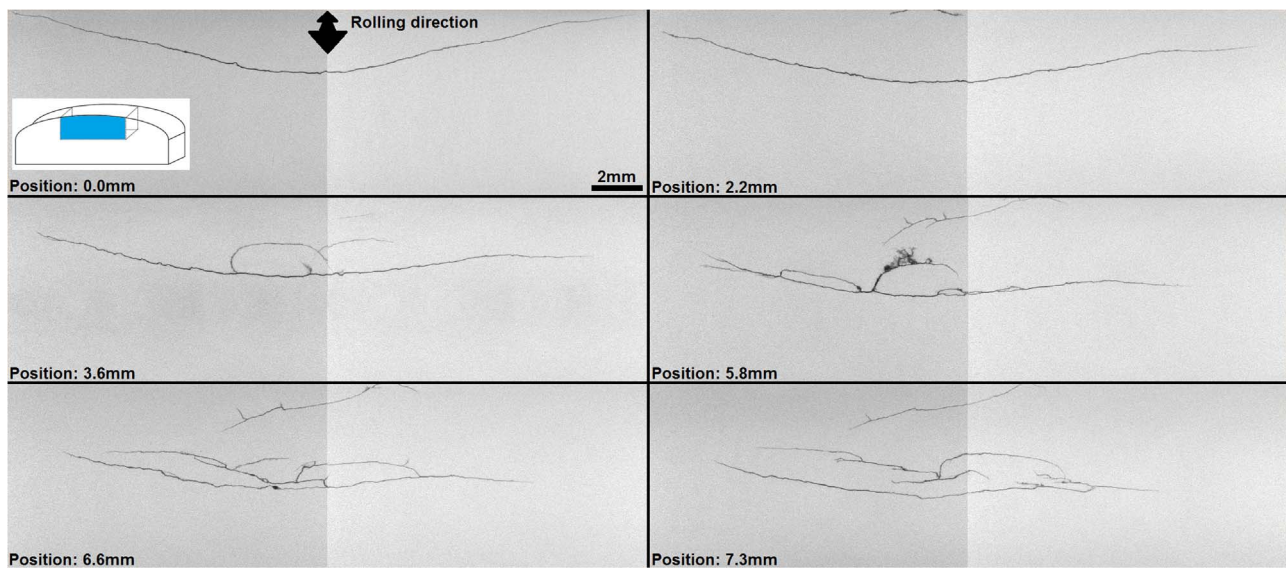
Fig. 8. A series of sections through the reconstructed volume containing part of a squat. The position of the sections is given along the rolling direction. The surface of the rail is approximately 400 μm above the top of each section.

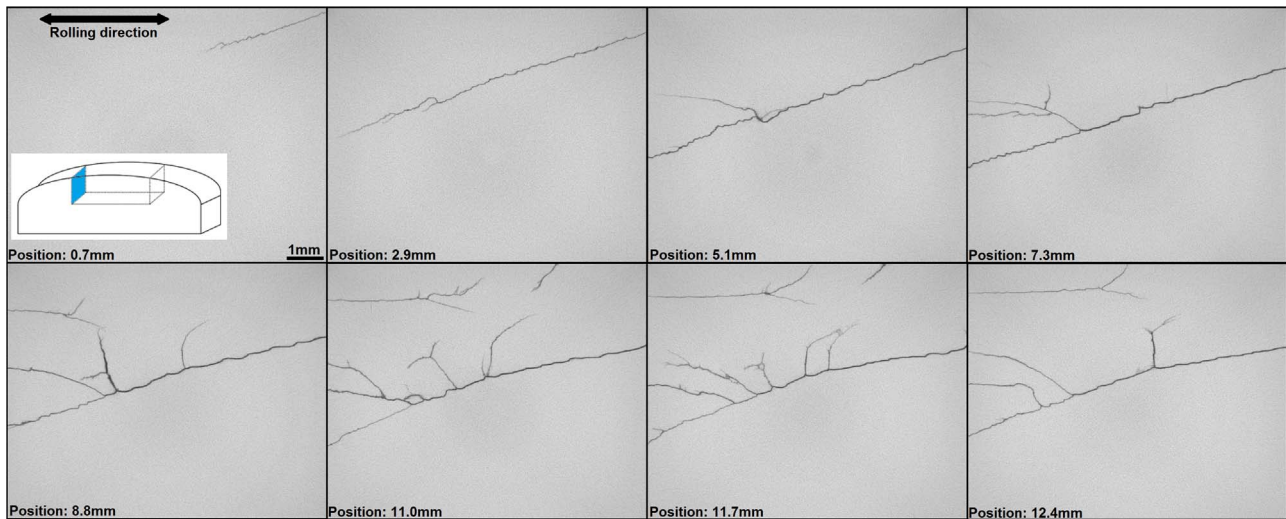
Fig. 9. A series of sections through half of the reconstructed volume of a part of a squat. The position of the sections is given transverse to the rolling direction. The surface of the rail is approximately $400\ \mu\text{m}$ above the top of each section a. (For interpretation of the references to color in this figure, the reader is referred to the web version of this article.)

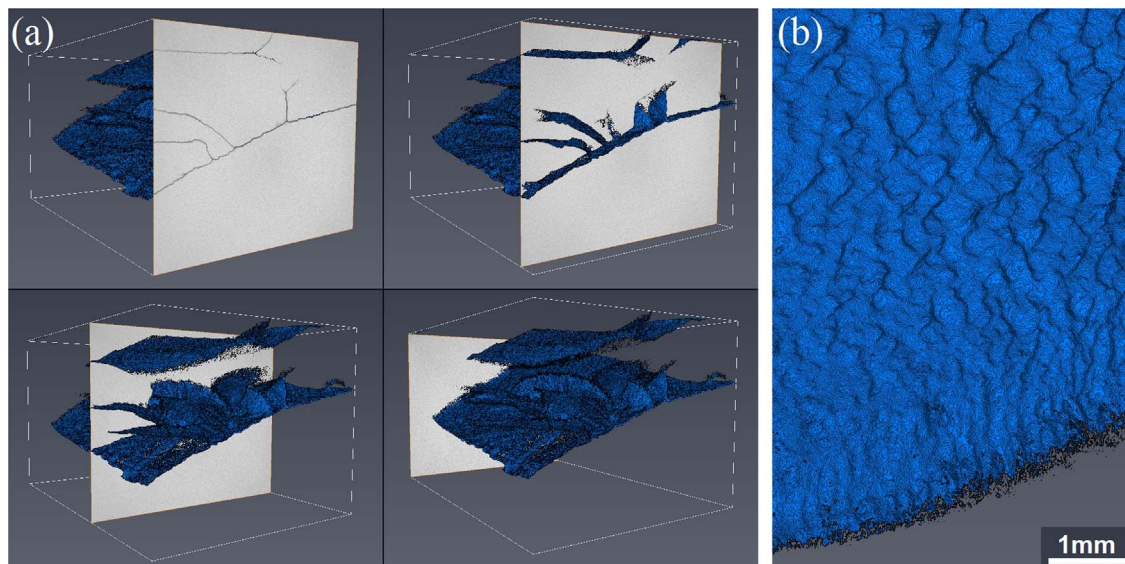
Fig. 10. (a) 3D representation of the crack network in blue from the same volume shown in Fig. 9. Four sections through the reconstructed volume illustrate how the images in Fig. 9 are taken. (b) Overhead view showing crack ridges. (For interpretation of the references to color in this figure legend, the reader is referred to the web version of this article.)

The 3D density maps obtained by reconstructing X-ray tomography data reveal density differences in the bulk material. The crack network was segmented and visualized by using the Avizo 3D software for materials science. Two overlapping regions were scanned tomographically to cover the squat in the transverse direction. The reconstructed volumes were stitched together and a series of 6 sections through this volume are presented in Fig. 8 along the rolling direction. The two different background contrasts represent the two individual reconstructions. The rolling direction is indicated by an arrow and the surface of the rail is approximately 400 μm above the top of the images. Fig. 9 shows one of the scans in the transverse direction. Fig. 10a shows a series of four consecutive sections through a reconstructed volume from the same angle as seen in Fig. 9. Cracks were located automatically by setting an intensity threshold value. Different parts of the 3D structure of the crack network, segmented in blue, are visible in Fig. 9. The same volume is seen from above in Fig. 10b, where part of the fracture surface is magnified. The ridges on the fracture surface of the squat are a characteristic of the RCF crack propagation in the rail. The distance between the ridges has been measured at 10 locations and varies between 200 and 500 μm .

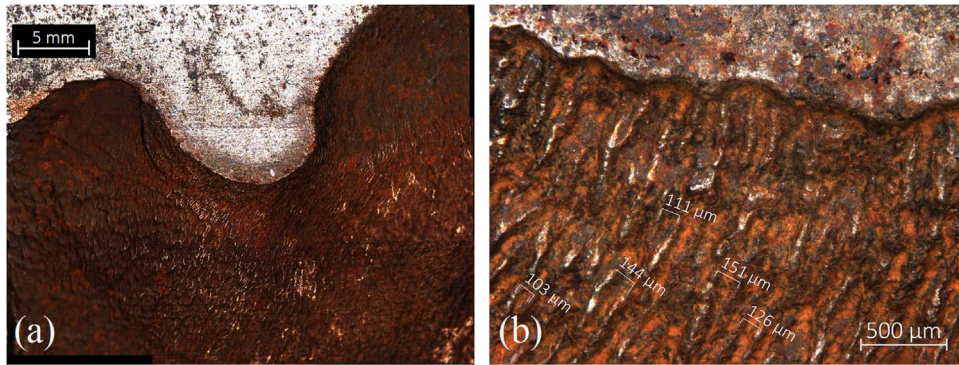
Fig. 11. Images from stereomicroscopy of (a) squat surface, and (b) detail of squat surface close to the tip of the v.

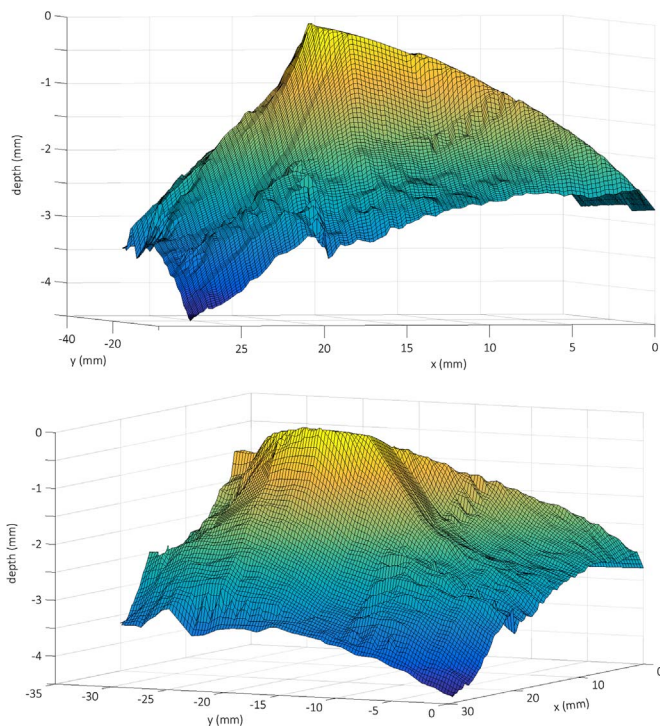
Fig. 12. Mapping of overall squat geometry, 1 mm step size.

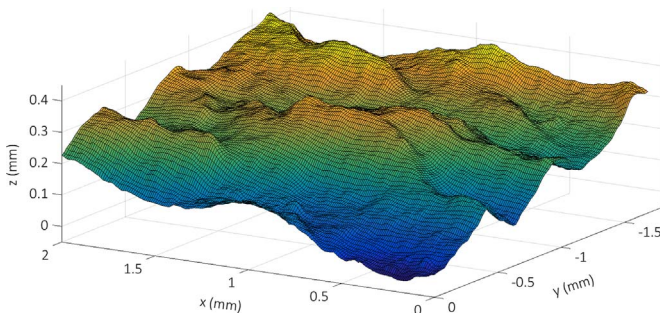
Fig. 13. Mapping from topography showing ridges, 50 μm step size.
